Preview of PCI's Japan Earthquake Reconnaissance Team Report

Richard Sause, Robert Frosch, S. K. Ghosh, Jason Lien,
Clay Naito, Larbi Sennour, and Toshi Yamanishi

The authors formed the PCI reconnaissance team that visited selected locations (**Fig. 1**) in Japan from June 27–30, 2011, following the Tohoku earthquake of March 11, 2011.

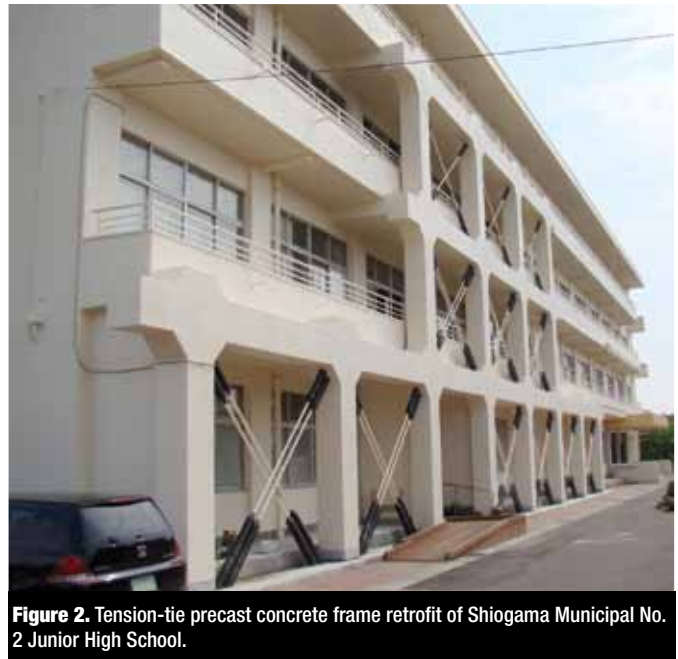
Figure 2. Tension-tie precast concrete frame retrofit of Shioyama Municipal No. 2 Junior High School.

The Shioyama Municipal No. 2 Junior High School (Fig. 2) was retrofitted in 2010 using an external precast concrete frame braced with tension ties. The existing cast-in-place concrete building was deficient in torsional resistance to earthquake loading. The north facade had stiff shear walls, while the south facade had moment frames, creating a torsional stiffness irregularity. The tension-tie-braced precast concrete frame increased the lateral stiffness along the south facade. The pieces included precast concrete columns anchored to the foundation using type II mechanical splices, architectural medallions on top of the columns, and drop beams between the medallions post-tensioned together on-site. To enhance the rigidity of the precast concrete frame, X-bracing with steel rods covered with plastic sleeves was used in the openings. Cast-in-place concrete diaphragms (Fig. 3) between the existing structure and precast concrete frame were used to transfer lateral shear forces to the external precast concrete frame. No damage to this structure was observed.

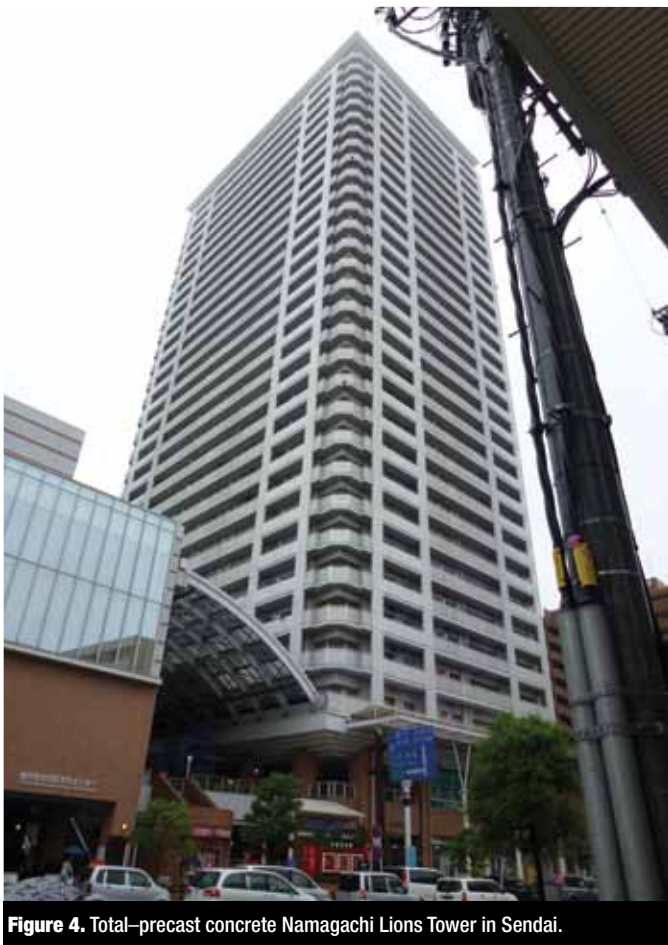
Figure 4. Total-precaster concrete Namagachi Lions Tower in Sendai.

The Namagachi Lions Tower (**Fig. 4**) in Sendai is a 29-story total-precaster concrete tower on a two-story, cast-in-place concrete podium. The structure was completed in 1999, and the lateral-force-resisting system consists of precast concrete moment-resisting frames. There was minor spalling near the base of three columns on the front of the building (**Fig. 5**). The only other visible damage was spalling of the underside of the slab (**Fig. 6**) at two opposite corners of the building, where two orthogonal beams that appeared to be unconnected came together. This damage did not appear to be significant, and the building appeared

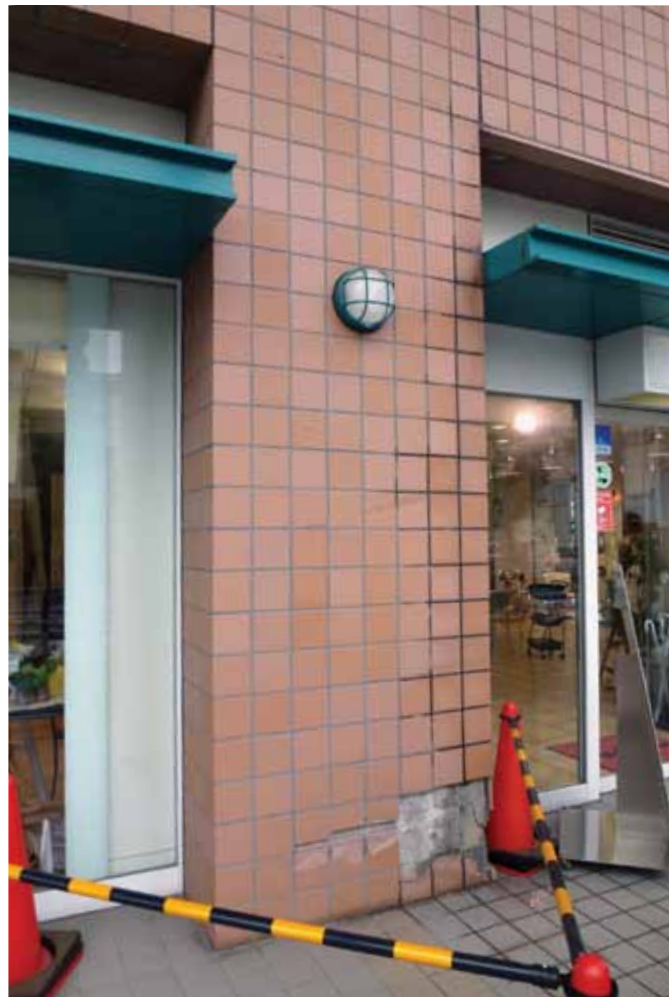
Figure 5. Minor spalling at the base of the columns of Namagachi Lions Tower.

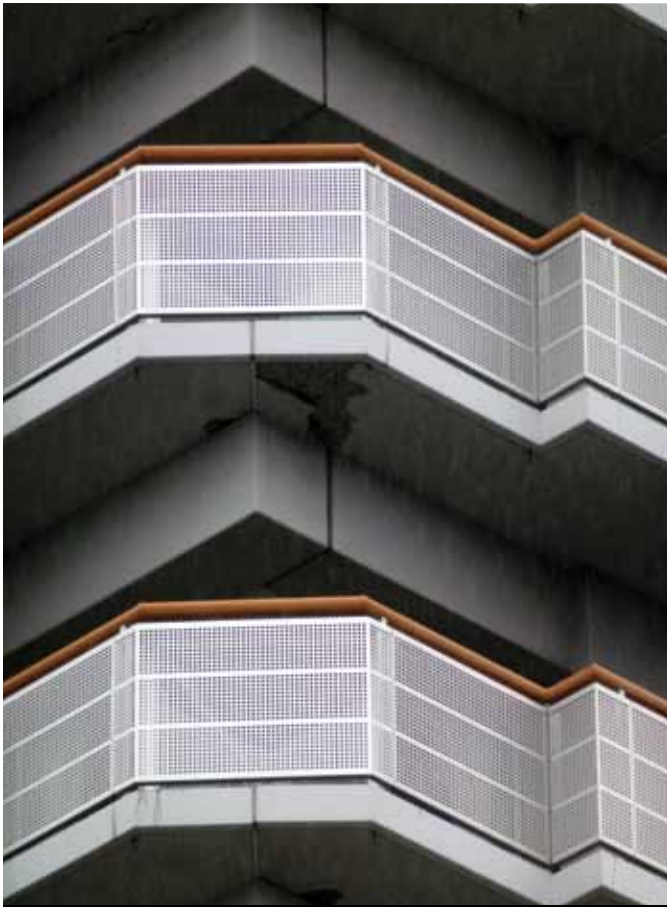
Figure 6. Spalling of slabs at corners of Namagachi Lions Tower.

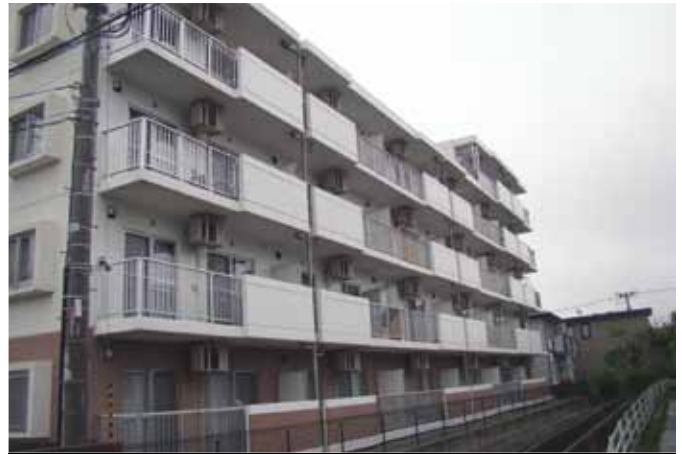
The four-story total-precaster concrete residential apartment building shown in **Fig. 7** was constructed in Natori City in 2006. The building has shear walls to provide earthquake resistance. Viewed from the exterior, the building appeared to have no structural damage or distress. Similar apartment buildings in the Kobe and Osaka area performed well in the 1995 Kobe earthquake.⁸

Figure 7. Three-story total-precast concrete apartment building at Natori City.
